**Flood Control Project Maintenance
Levee Inspections****LMA District Cover Sheet****Spring 2014 Levee Inspection Results****Sutter Maintenance Yard East-West Interceptor**

Spring 2014 Levee Inspection Results

Sutter Maintenance Yard East-West Interceptor

Levee Inspection Report By Mile - Spring 2014

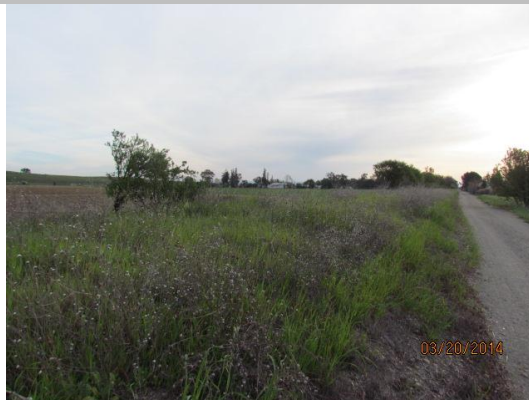
Photo 1 of 1 : rduffey_s_20140407_137.jpg

LM Start	0.00	Rating **	M	Issue No.	7
LM End	0.32	Issue Type +	Ma	Location *	WS
Category	Earthen Levee			GPS Latitude/Longitude	
				Start	End
Item	Vegetation			39.171577 °	39.171481 °
				-121.760019 °	-121.754826 °
DWR ID	DWR_NA0020_01_s _ 2012_7				
Action/Comments					
Remove the wild growth other than native grasses from the levee slopes.

View of the vegetation along the w/s toe.

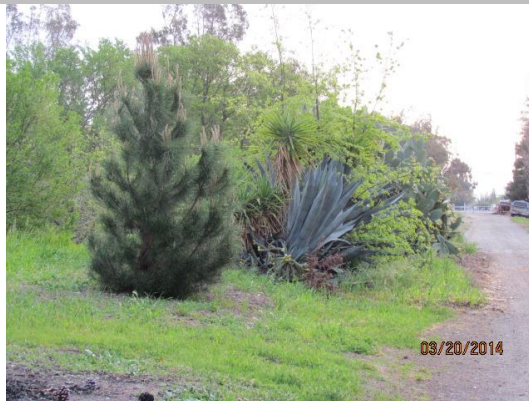
Photo 1 of 1 : rduffey_s_20140407_139.jpg

LM Start	0.23	Rating **	M	Issue No.	2
LM End	0.25	Issue Type +	En	Location *	CR
Category	Earthen Levee			GPS Latitude/Longitude	
				Start	End
Item	Vegetation			39.171418 °	39.171408 °
				-121.755963 °	-121.755578 °
DWR ID	DWR_NA0020_01_s_2012_2				
Action/Comments					
Landscaping

View of the cactus and pine trees along w/s berm.

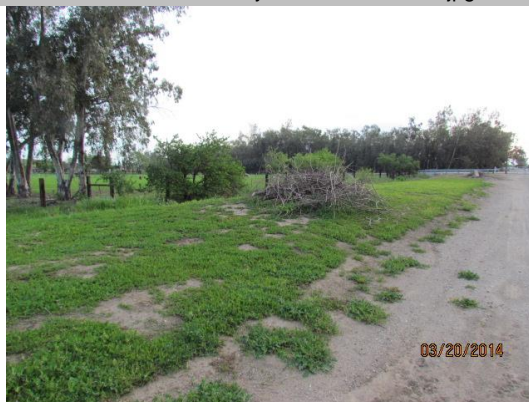
Photo 1 of 1 : rduffey_s_20140407_140.jpg

LM Start	0.36	Rating **	M	Issue No.	23
LM End	0.36	Issue Type +	En	Location *	CR
Category	Earthen Levee			GPS Latitude/Longitude	
				Start	End
Item	Encroachments			39.171450 °	39.171450 °
				-121.754058 °	-121.754058 °
DWR ID	DWR_NA0020_01_f_2013_23				
Action/Comments					
Prunings

View of the tree limbs and debris on the w/s berm.

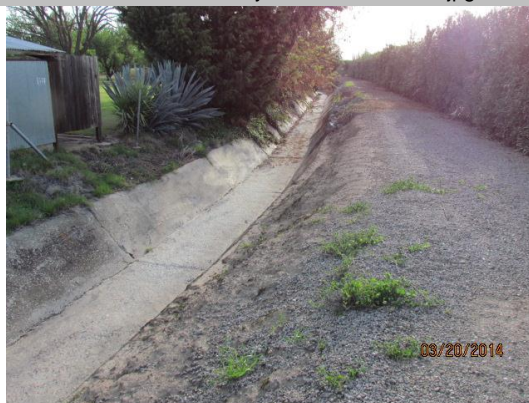
Photo 1 of 1 : rduffey_s_20140407_141.jpg

LM Start	0.62	Rating **	U	Issue No.	4
LM End	0.65	Issue Type +	Ma	Location *	WS
Category	Earthen Levee			GPS Latitude/Longitude	
				Start	End
Item	Erosion / Bank Caving			39.171292 °	39.171232 °
				-121.748868 °	-121.748175 °
DWR ID	DWR_NA0020_01_s _ 2012_4				
Action/Comments					
Schedule repair of erosion site prior to the next inspection.

View of the erosion along the concrete ditch on the w/s slope.

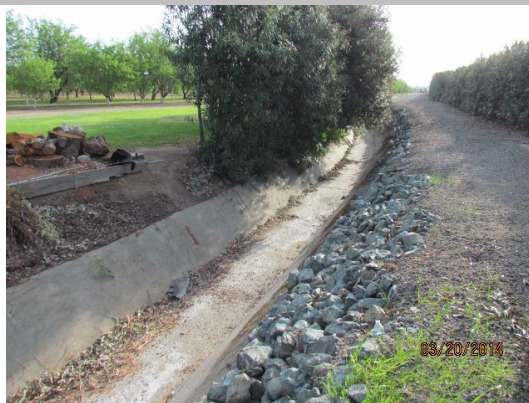
Photo 1 of 1 : rduffey_s_20140407_142.jpg

LM Start	0.63	Rating **	A	Issue No.	102
LM End	0.63	Issue Type +	Ma	Location *	WS
Category	Earthen Levee			GPS Latitude/Longitude	
				Start	End
Item	Erosion / Bank Caving			39.171329 °	39.171329 °
				-121.748235 °	-121.748235 °
DWR ID	DWR_ST0020_01_s _ 2014_102				
Action/Comments					
Note and monitor erosion site.

View of the repaired erosion along the w/s ditch.

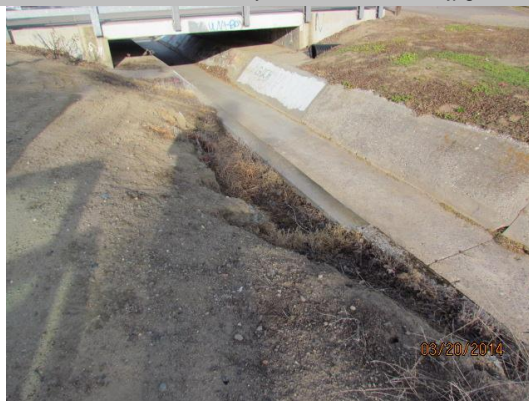
Photo 1 of 1 : rduffey_s_20140407_143.jpg

LM Start	0.88	Rating **	M	Issue No.	8
LM End	0.88	Issue Type +	Ma	Location *	WS
Category	Earthen Levee			GPS Latitude/Longitude	
				Start	End
Item	Erosion / Bank Caving			39.171335 °	39.171335 °
				-121.744039 °	-121.744039 °
DWR ID	DWR_NA0020_01_s _ 2012_8				
Action/Comments					
Note and monitor erosion site.

View of the erosion along the w/s ditch.

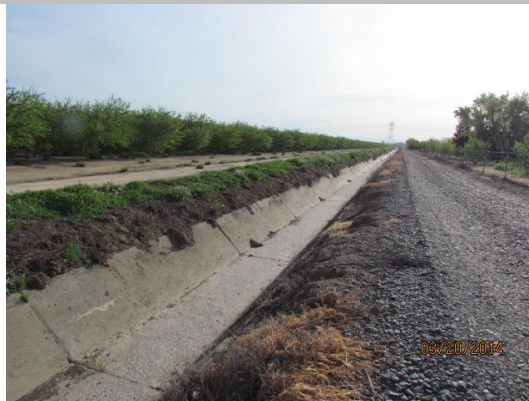
Photo 1 of 1 : rduffey_s_20140407_144.jpg

LM Start	0.92	Rating **	M	Issue No.	12
LM End	1.01	Issue Type +	Ma	Location *	WS
Category	Earthen Levee			GPS Latitude/Longitude	
				Start	End
Item	Erosion / Bank Caving			39.171329 °	39.171310 °
				-121.742385 °	-121.741178 °
DWR ID	DWR_NA0020_01_f_2012_12				
Action/Comments					
Note and monitor erosion site.

View of the erosion along the West interceptor canal.

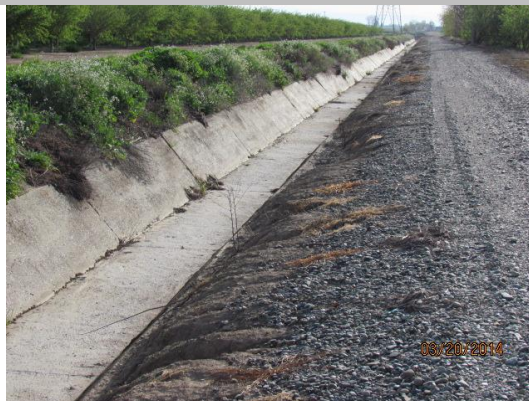
Photo 1 of 1 : rduffey_s_20140407_145.jpg

LM Start	1.03	Rating **	M	Issue No.	14
LM End	1.07	Issue Type +	Ma	Location *	LS
Category	Earthen Levee			GPS Latitude/Longitude	
				Start	End
Item	Erosion / Bank Caving			39.171314 °	39.171300 °
				-121.740994 °	-121.740173 °
DWR ID	DWR_NA0020_01_s_2013_14				
Action/Comments					
Note and monitor erosion site.

View of the erosion along the West interceptor canal.

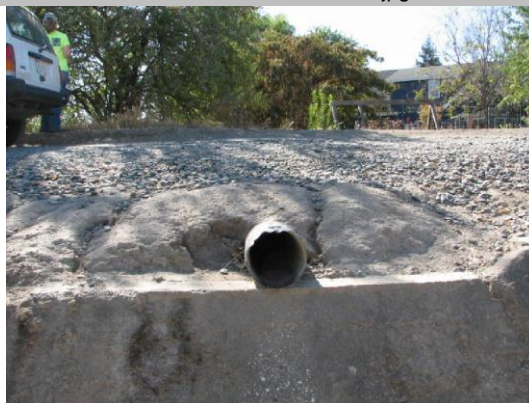
Photo 1 of 1 : UCIP_3564.jpg

LM Start	1.09	Rating **	M	Issue No.	99
LM End	1.09	Issue Type +	En	Location *	LS
Category	Supplemental			GPS Latitude/Longitude	
				Start	End
Item	DWR UCIP Field Study			39.171296 °	39.171296 °
				-121.739779 °	-121.739779 °
DWR ID	DWR_ST0020_01_s _ 2014_99				
Action/Comments					
Inspector Comments: FS_ID:23635					
EP_NO: N/A					
Repair Type:					
Crossing Status:					
UCIP Comments: Pipe not permitted and has no flap gate 5/15/2013					
Same as last inspection 11/4/2013 Same as last inspection.					
FIELD_STRUCT_DESC: 8-inch corrugated metal drain pipe through the					
levee 1.5-feet below the crown. Unable to locate the inlet.					
FS Date: 11/4/2013 2:35:54 PM

Pipe at outlet on WS crown.

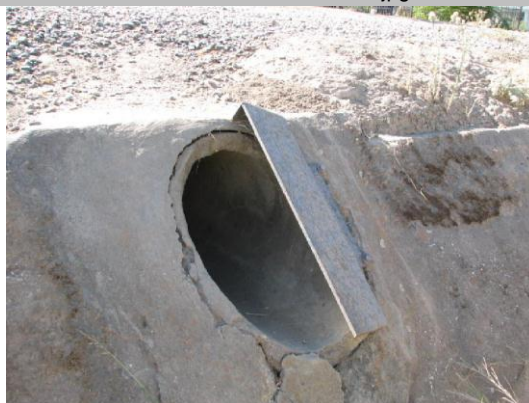
Photo 1 of 1 : UCIP_3563.jpg

LM Start	1.09	Rating **	M	Issue No.	100
LM End	1.09	Issue Type +	En	Location *	LS
Category	Supplemental			GPS Latitude/Longitude	
				Start	End
Item	DWR UCIP Field Study			39.171301 °	39.171301 °
				-121.739799 °	-121.739799 °
DWR ID	DWR_ST0020_01_s _ 2014_100				
Action/Comments					
Inspector Comments: FS_ID:23634					
EP_NO: 12746					
Repair Type:					
Crossing Status:					
UCIP Comments: There is no flap gate or other device to prevent water from flowing back through the pipe at the outlet 5/15/2013 Same as last inspection 1/4/2013 Same as last inspection.					
FIELD_STRUCT_DESC: 24-inch concrete storm drain pipe through the levee 2-feet below the crown with a steel deflector at outlet. (Permit No. 12746, 1979, Garcia).					
FS Date: 11/4/2013 2:35:05 PM

Outlet in channel with steel deflector over pipe outlet.

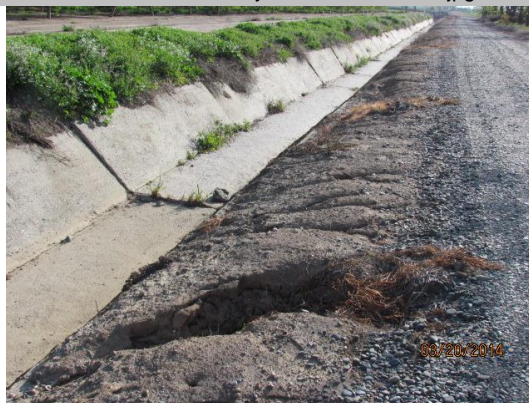
Photo 1 of 1 : rduffey_s_20140407_146.jpg

LM Start	1.16	Rating **	M	Issue No.	13
LM End	1.24	Issue Type +	Ma	Location *	WS
Category	Earthen Levee			GPS Latitude/Longitude	
				Start	End
Item	Erosion / Bank Caving			39.171271 °	39.171252 °
				-121.738194 °	-121.736868 °
DWR ID	DWR_NA0020_01_f_2012_13				
Action/Comments					
Note and monitor erosion site.

You of the erosion along the West interceptor canal.

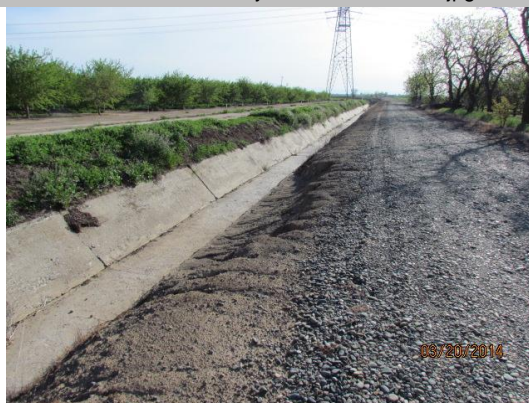
Photo 1 of 1 : rduffey_s_20140407_150.jpg

LM Start	1.23	Rating **	M	Issue No.	3
LM End	1.24	Issue Type +	Ma	Location *	WS
Category	Earthen Levee			GPS Latitude/Longitude	
				Start	End
Item	Erosion / Bank Caving			39.171380 °	39.171380 °
				-121.737337 °	-121.737337 °
DWR ID	DWR_NA0020_01_s_2012_3				
Action/Comments					
Note and monitor erosion site.

View of the erosion along West interceptor canal.

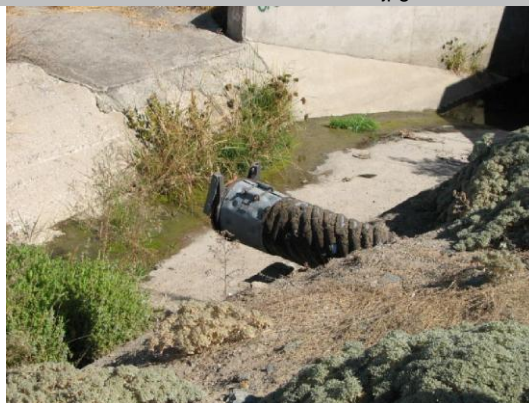
Photo 1 of 1 : UCIP_3567.jpg

LM Start	1.34	Rating **	M	Issue No.	101
LM End	1.34	Issue Type +	En	Location *	WS
Category	Supplemental			GPS Latitude/Longitude	
				Start	End
Item	DWR UCIP Field Study			39.171198 °	39.171198 °
				-121.735125 °	-121.735125 °
DWR ID	DWR_ST0020_01_s _ 2014_101				
Action/Comments					
Inspector Comments: FS_ID:23637					
EP_NO: 15946					
Repair Type:					
Crossing Status:					
UCIP Comments: Inlet is completely blocked with soil 11/15/2013					
Same as last inspection 11/4/2013 Same as last inspection.					
FIELD_STRUCT_DESC: 12-inch CMP drain line through the levee 2-					
feet below the crown encased in concrete with flap gate on water side.					
Permit No. 15946 (1992) Design drawings available in permit.					
FS Date: 11/4/2013 2:37:32 PM

Coated CMP at outlet.

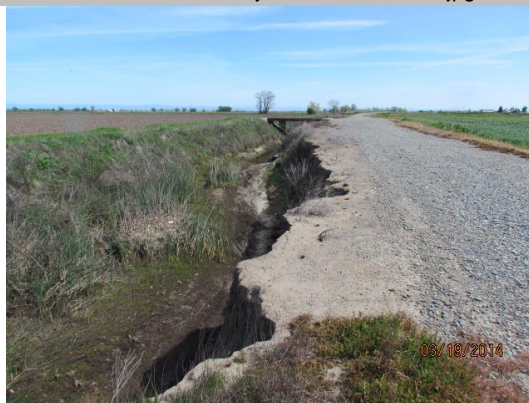
Photo 1 of 1 : rduffey_s_20140407_149.jpg

LM Start	1.67	Rating **	M	Issue No.	6
LM End	1.67	Issue Type +	Ma	Location *	WS
Category	Channels			GPS Latitude/Longitude	
				Start	End
Item	Erosion / Bank Caving			39.171128 °	39.171128 °
				-121.729235 °	-121.729235 °
DWR ID	DWR_NA0020_01_s _ 2012_6				
Action/Comments					
Inspector Comments: Sutter Yard needs to repair the channel.

View of the erosion along the w/s slope.

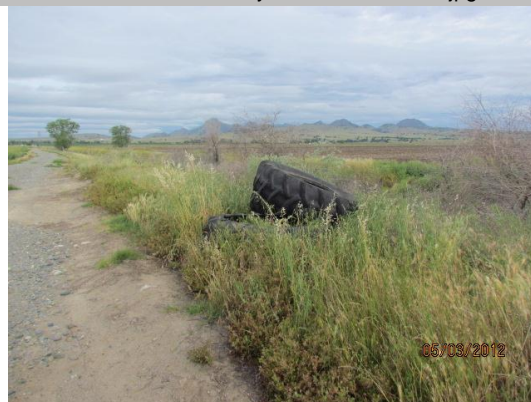
Photo 1 of 1 : rduffey_s_20140304_793.jpg

LM Start	0.25	Rating **	M	Issue No.	12
LM End	0.25	Issue Type +	En	Location *	WS
Category	Earthen Levee			GPS Latitude/Longitude	
				Start	End
Item	Encroachments			39.171107 °	39.171107 °
				-121.722069 °	-121.722069 °
DWR ID	DWR_NA0020_02_s _ 2012_12				
Action/Comments					
Garbage					
Inspector Comments: Tires

View of the tires along the W/S toe.

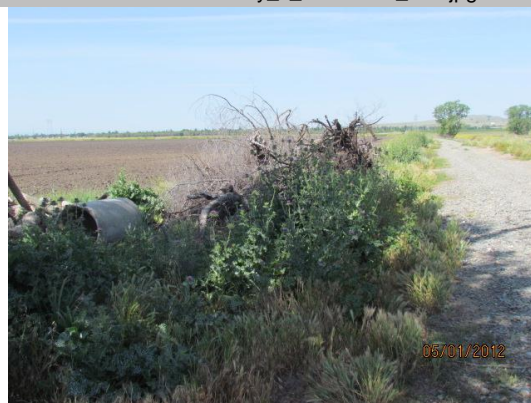
Photo 1 of 1 : rduffey_s_20140304_791.jpg

LM Start	0.26	Rating **	M	Issue No.	9
LM End	0.26	Issue Type +	En	Location *	LS
Category	Earthen Levee			GPS Latitude/Longitude	
				Start	End
Item	Encroachments			39.171101 °	39.171101 °
				-121.721856 °	-121.721856 °
DWR ID	DWR_NA0020_02_s _ 2012_9				
Action/Comments					
Debris

View of the debris along the L/S toe.

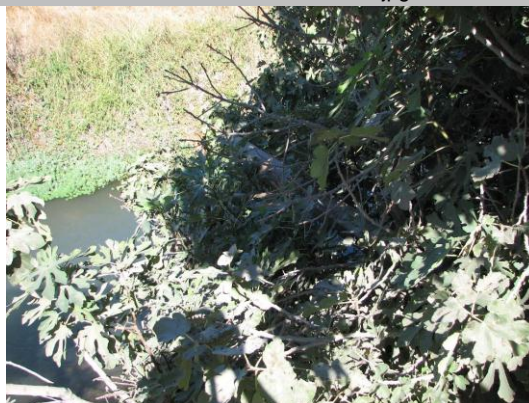
Photo 1 of 1 : UCIP_3570.jpg

LM Start	0.39	Rating **	M	Issue No.	1
LM End	0.39	Issue Type +	En	Location *	LS
Category	Supplemental			GPS Latitude/Longitude	
				Start	End
Item	DWR UCIP Field Study			39.171067 °	39.171067 °
				-121.719217 °	-121.719217 °
DWR ID	DWR_ST0020_02_s _ 2014_1				
Action/Comments					
Inspector Comments: FS_ID:23642					
EP_NO: N/A					
Repair Type:					
Crossing Status:					
UCIP Comments: Pipe and pump abandoned. Pipe should be removed or properly abandoned 5/15/2013 Same as last inspection 11/4/2013 Same as last inspection.					
FIELD_STRUCT_DESC: 8-inch iron irrigation pipe through the levee 2-feet below crown. 7.5 HP Pump in canal. Originally included in O+M manual 1953. See As-builts Dwg. 50-10-2816.					
FS Date: 11/4/2013 2:41:32 PM

Pipe on LS slope.

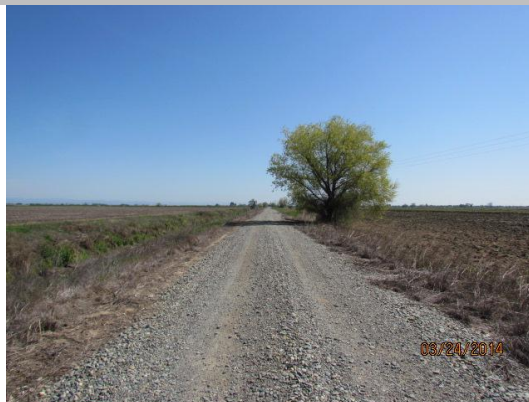
Photo 1 of 1 : rduffey_s_20140324_131.jpg

LM Start	0.55	Rating **	M	Issue No.	2
LM End	2.72	Issue Type +	Ma	Location *	WS
Category	Earthen Levee			GPS Latitude/Longitude	
				Start	End
Item	Vegetation			39.171002 °	39.170507 °
				-121.716293 °	-121.676212 °
DWR ID	DWR_NA0020_02_s _ 2012_2				
Action/Comments					
Remove the wild growth other than native grasses from the levee slopes.

View of the vegetation on both slopes.

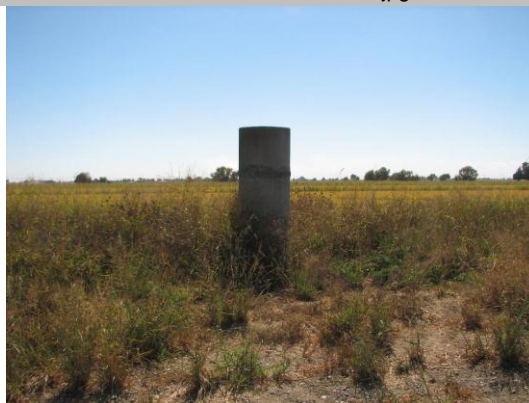
Photo 1 of 1 : UCIP_3573.jpg

LM Start	0.74	Rating **	M	Issue No.	13
LM End	0.74	Issue Type +	En	Location *	WS
Category	Supplemental			GPS Latitude/Longitude	
				Start	End
Item	DWR UCIP Field Study			39.170989 °	39.170989 °
				-121.712650 °	-121.712650 °
DWR ID	DWR_ST0020_02_s _ 2014_13				
Action/Comments					
Inspector Comments: FS_ID:23643					
EP_NO: N/A					
Repair Type:					
Crossing Status:					
UCIP Comments: Pumping plant abandoned. Pipe abandoned and only visible at bottom of concrete standpipe. Pipe needs to be abandoned properly 5/15/2013 Same as last inspection 11/4/2013					
Same as last inspection.					
FIELD_STRUCT_DESC: 12-inch iron irrigation pipe through the levee 6-feet below the crown. Power pole on waterward shoulder with pump on berm. 36-inch concrete standpipe on LS shoulder. Originally included in O+M manual 1953. See As-builts Dwg. 50-10-2816.					
FS Date: 11/4/2013 2:43:51 PM

Concrete standpipe on LS shoulder.

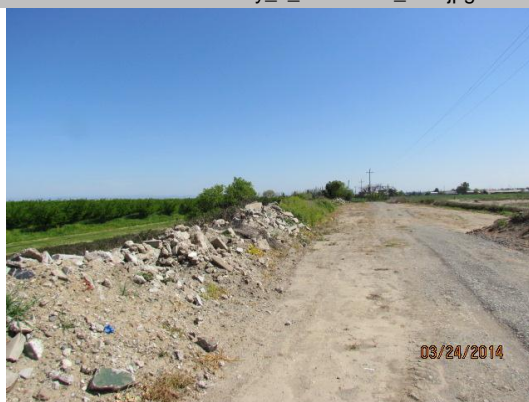
Photo 1 of 1 : rduffey_s_20140324_132.jpg

LM Start	1.43	Rating **	M	Issue No.	3
LM End	1.55	Issue Type +	Ma	Location *	LS
Category	Earthen Levee			GPS Latitude/Longitude	
				Start	End
Item	Encroachments			39.170782 °	39.170817 °
				-121.700167 °	-121.698203 °
DWR ID	DWR_NA0020_02_s _ 2012_3				
Action/Comments					
Debris

View of the piles of broken concrete next to the levee.

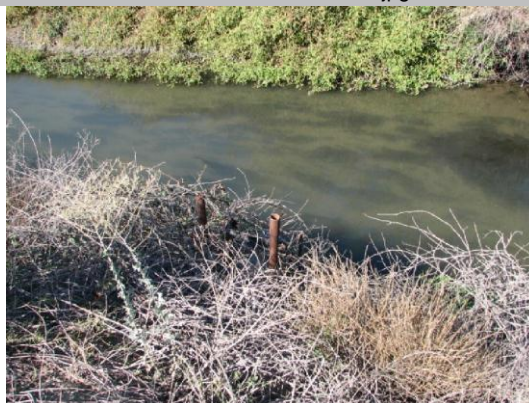
Photo 1 of 1 : UCIP_3575.jpg

LM Start	1.54	Rating **	M	Issue No.	14
LM End	1.54	Issue Type +	En	Location *	LS
Category	Supplemental			GPS Latitude/Longitude	
				Start	End
Item	DWR UCIP Field Study			39.170847 °	39.170847 °
				-121.697888 °	-121.697888 °
DWR ID	DWR_ST0020_02_s _ 2014_14				
Action/Comments					
Inspector Comments: FS_ID:23648					
EP_NO: N/A					
Repair Type:					
Crossing Status:					
UCIP Comments: LS intake is filled and blocked with soil 5/15/2013					
Same as last inspection 11/4/2013 Same as last inspection.					
FIELD_STRUCT_DESC: 16-inch corrugated metal pipe through the					
levee 5-feet below the crown. Flap gate on waterward end.					
FS Date: 11/4/2013 2:48:03 PM

Pipe with flapgate at outlet on WS slope.

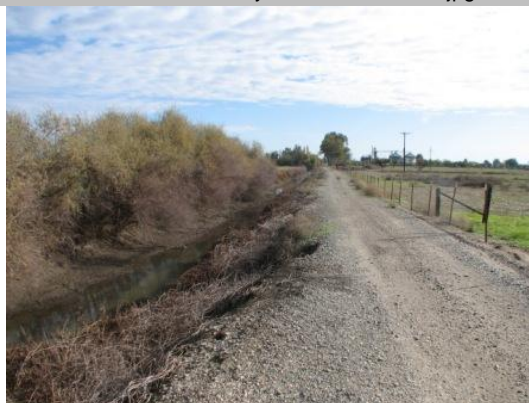
Photo 1 of 1 : rduffey_s_20140304_788.jpg

LM Start	1.54	Rating **	M	Issue No.	4
LM End	1.93	Issue Type +	Ma	Location *	WS
Category	Earthen Levee			GPS Latitude/Longitude	
				Start	End
Item	Erosion / Bank Caving			39.170800 °	39.170702 °
				-121.698105 °	-121.690788 °
DWR ID	DWR_NA0020_02_s _ 2012_4				
Action/Comments					
Note and monitor erosion site.

View of the erosion along the waterside slope.

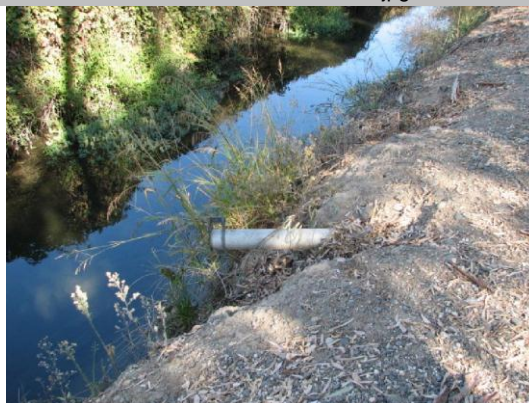
Photo 1 of 1 : UCIP_3579.jpg

LM Start	1.74	Rating **	M	Issue No.	16
LM End	1.74	Issue Type +	En	Location *	WS
Category	Supplemental			GPS Latitude/Longitude	
				Start	End
Item	DWR UCIP Field Study			39.170832 °	39.170832 °
				-121.694174 °	-121.694174 °
DWR ID	DWR_ST0020_02_s _ 2014_16				
Action/Comments					
Inspector Comments: FS_ID:23651					
EP_NO: N/A					
Repair Type:					
Crossing Status:					
UCIP Comments: No permit identified for crossing5/15/2013 Same as last inspection11/4/2013 Same as last inspection.					
FIELD_STRUCT_DESC: 7-inch flexible HDPE storm drain pipe through the levee 1-foot below the crown.					
FS Date: 11/4/2013 2:49:52 PM

HDPE pipe on upstream side of aluminum pipe shown in picture.

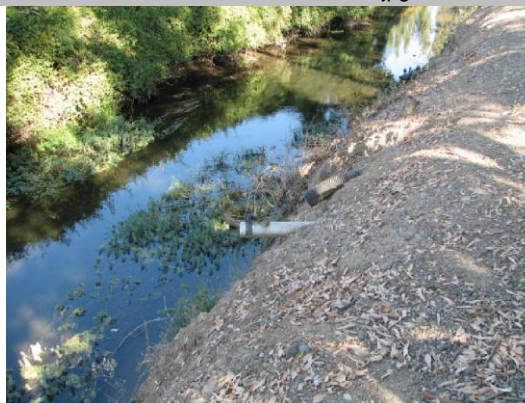
Photo 1 of 1 : UCIP_3582.jpg

LM Start	1.76	Rating **	M	Issue No.	20
LM End	1.76	Issue Type +	En	Location *	WS
Category	Supplemental			GPS Latitude/Longitude	
				Start	End
Item	DWR UCIP Field Study			39.170806 °	39.170806 °
				-121.693769 °	-121.693769 °
DWR ID	DWR_ST0020_02_s _ 2014_20				
Action/Comments					
Inspector Comments: FS_ID:23653					
EP_NO: N/A					
Repair Type:					
Crossing Status:					
UCIP Comments: No permit identified for crossing5/15/2013 Same as last inspection11/4/2013 Same as last inspection.					
FIELD_STRUCT_DESC: 7-inch flexible HDPE storm drain pipe through the levee 1-foot below the crown.					
FS Date: 11/4/2013 2:50:40 PM

HDPE pipe on WS shoulder.

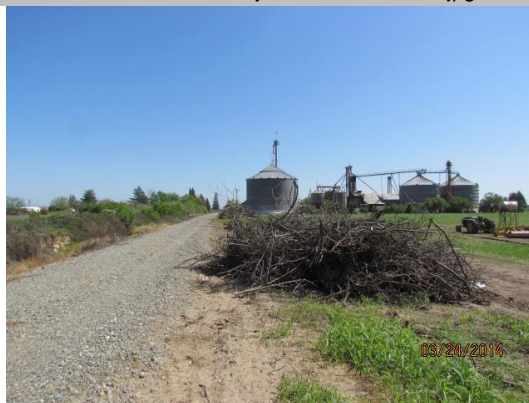
Photo 1 of 1 : rduffey_s_20140324_133.jpg

View of the tree prunings along the landside slope.

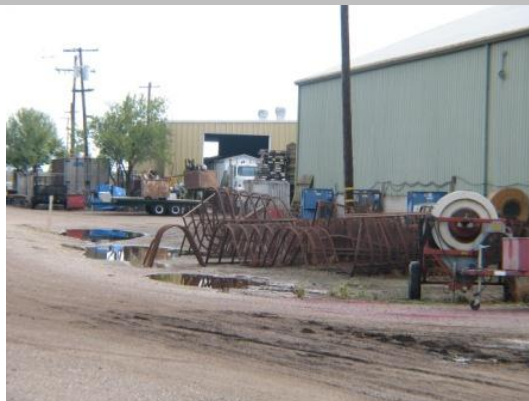
Photo 1 of 1 : rduffey_s_20140304_789.jpg

LM Start	1.92	Rating **	M	Issue No.	5
LM End	2.04	Issue Type +	Ma	Location *	LS
Category	Earthen Levee			GPS Latitude/Longitude	
				Start	End
Item	Encroachments			39.171104 °	39.171104 °
				-121.718880 °	-121.718876 °
DWR ID	DWR_NA0020_02_s _ 2012_5				
Action/Comments					
Equipment

View of the equipment and buildings next to the landside berm.

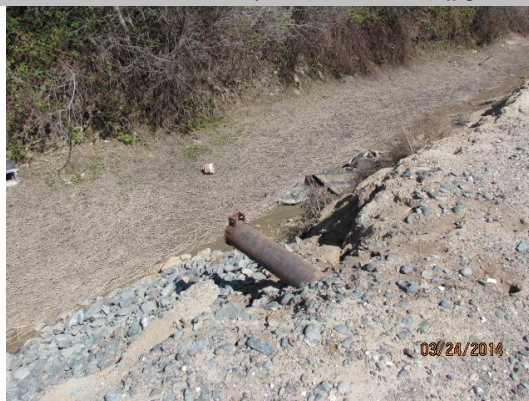
Photo 1 of 1 : rduffey_s_20140324_134.jpg

LM Start	1.93	Rating **	U	Issue No.	26
LM End	1.93	Issue Type +	En	Location *	CR
Category	Earthen Levee			GPS Latitude/Longitude	
				Start	End
Item	Encroachments			39.170743 °	39.170743 °
				-121.690644 °	-121.690644 °
DWR ID	DWR_ST0020_02_s _ 2014_26				
Action/Comments					
Pipe

View of the unauthorized pipe going through the crown of the levee.

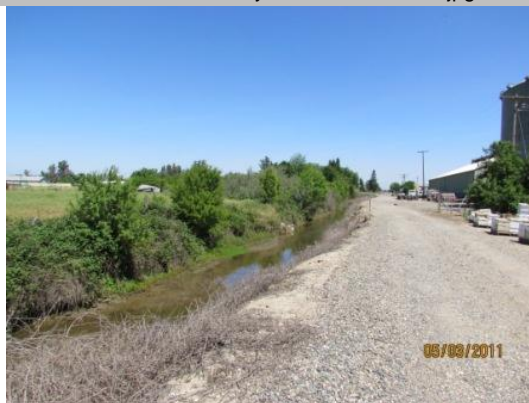
Photo 1 of 1 : rduffey_s_20140304_790.jpg

View of the erosion along the W/S slope.

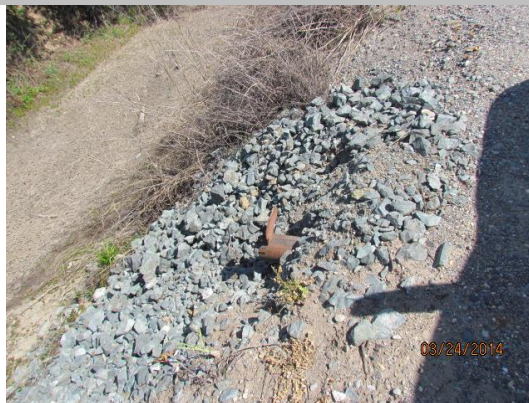
Photo 1 of 1 : rduffey_s_20140324_135.jpg

LM Start	1.97	Rating **	U	Issue No.	27
LM End	1.97	Issue Type +	En	Location *	CR
Category	Earthen Levee			GPS Latitude/Longitude	
				Start	End
Item	Encroachments			39.170777 °	39.170777 °
				-121.689820 °	-121.689820 °
DWR ID	DWR_ST0020_02_s _ 2014_27				
Action/Comments					
Pipe

View of the unauthorized pipe going through the crown of the levee.

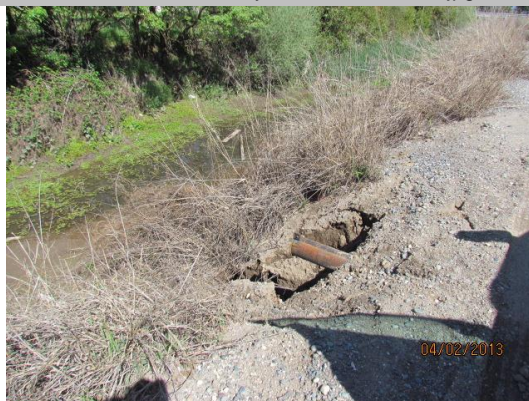
Photo 1 of 1 : rduffey_s_20140304_794.jpg

LM Start	2.02	Rating **	M	Issue No.	17
LM End	2.02	Issue Type +	Ma	Location *	WS
Category	Earthen Levee			GPS Latitude/Longitude	
				Start	End
Item	Erosion / Bank Caving			39.170756 °	39.170756 °
				-121.689841 °	-121.689841 °
DWR ID	DWR_NA0020_02_s _ 2013_17				
Action/Comments					
Note and monitor erosion site.

View of the erosion caused by the unauthorized pipe.

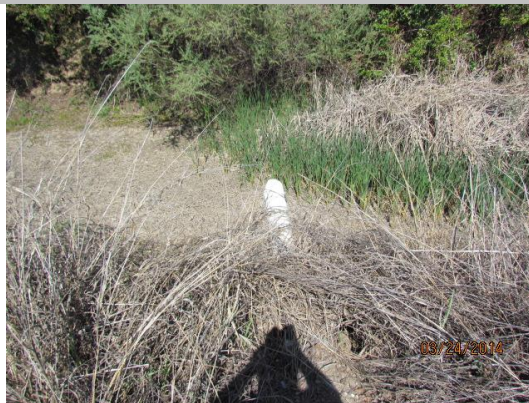
Photo 1 of 1 : rduffey_s_20140324_136.jpg

View of the unauthorized pipe going through the crown of the levee.

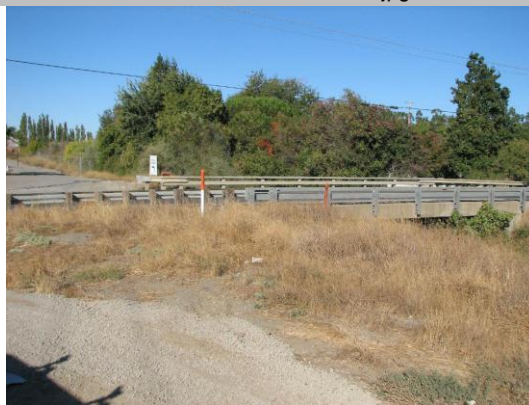
Photo 1 of 1 : UCIP_3584.jpg

LM Start	2.05	Rating **	M	Issue No.	22
LM End	2.05	Issue Type +	En	Location *	WS
Category	Supplemental			GPS Latitude/Longitude	
				Start	End
Item	DWR UCIP Field Study			39.170708 °	39.170708 °
				-121.688572 °	-121.688572 °
DWR ID	DWR_ST0020_02_s _ 2014_22				
Action/Comments					
Inspector Comments: FS_ID:23658					
EP_NO: N/A					
Repair Type:					
Crossing Status:					
UCIP Comments: No permit identified for this crossing5/15/2013					
Same as last inspection11/4/2013 Same as last inspection.					
FIELD_STRUCT_DESC: Fiber optic line through the levee at unknown					
depth crossing on east side of Township road bridge.					
FS Date: 11/4/2013 2:56:14 PM

Marker on east side of N Township Drive, south of interceptor.

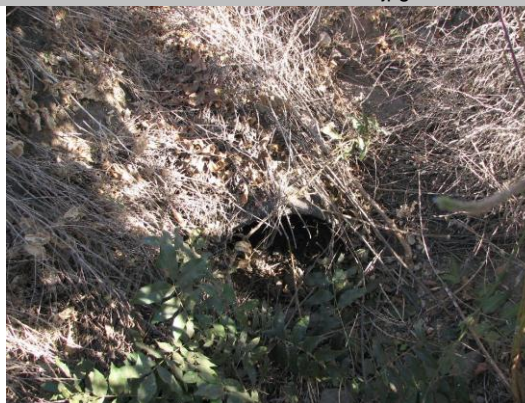
Photo 1 of 1 : UCIP_3590.jpg

LM Start	2.05	Rating **	M	Issue No.	24
LM End	2.05	Issue Type +	En	Location *	WS
Category	Supplemental			GPS Latitude/Longitude	
				Start	End
Item	DWR UCIP Field Study			39.170639 °	39.170639 °
				-121.688445 °	-121.688445 °
DWR ID	DWR_ST0020_02_s _ 2014_24				
Action/Comments					
Inspector Comments: FS_ID:23660					
EP_NO: N/A					
Repair Type:					
Crossing Status:					
UCIP Comments: No permit identified for this crossing 5/15/2013					
Same as last inspection 11/4/2013 Same as last inspection.					
FIELD_STRUCT_DESC: 18-inch asphalt coated corrugated metal storm drain pipe through the levee 6-feet below the crown. Flap gate on water side.					
FS Date: 11/4/2013 2:57:10 PM

Pipe on LS toe.

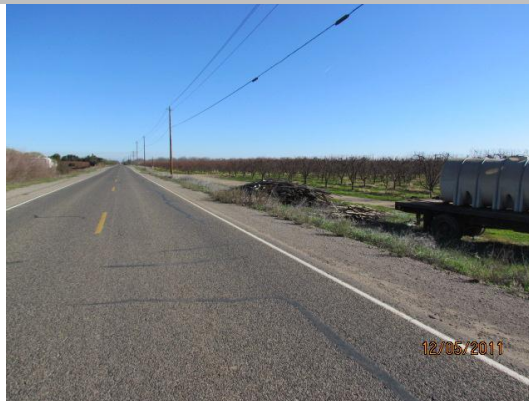
Photo 1 of 1 : rduffey_s_20140304_792.jpg

View of material, garbage & equipment along the L/S toe.
